## **Tree Condition Report for Bingham Town Council**

**12th August 2020**

# AT2 Tree Surveys

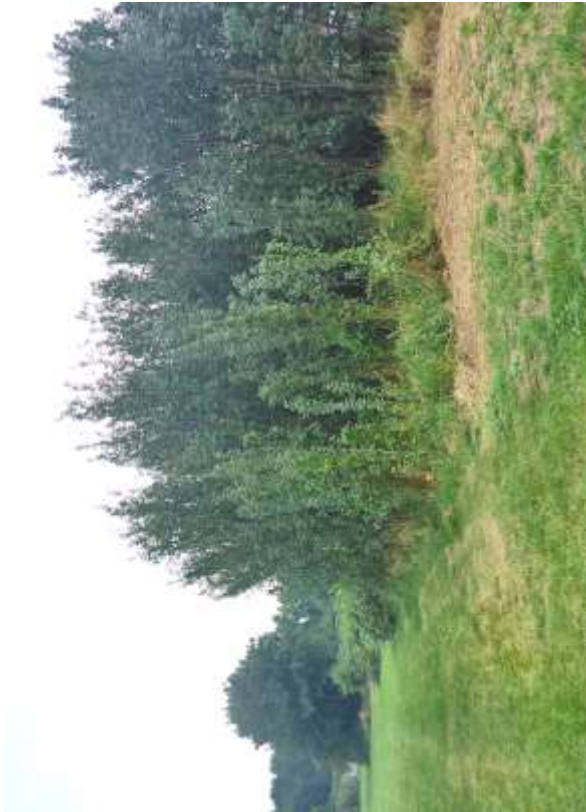
Ref.	Name/species	Age category	Physiological condition	Structural condition	BS5837 Grading	Recommendations	Priority	W3W Location
1	Mixed group	Young	Poor	Poor	U	Wild area of goat willow, brambles and cherry suckers. Clear and then reinstate mowing to control spread.

**1. Clear sucker growth & reinstate mowing.**

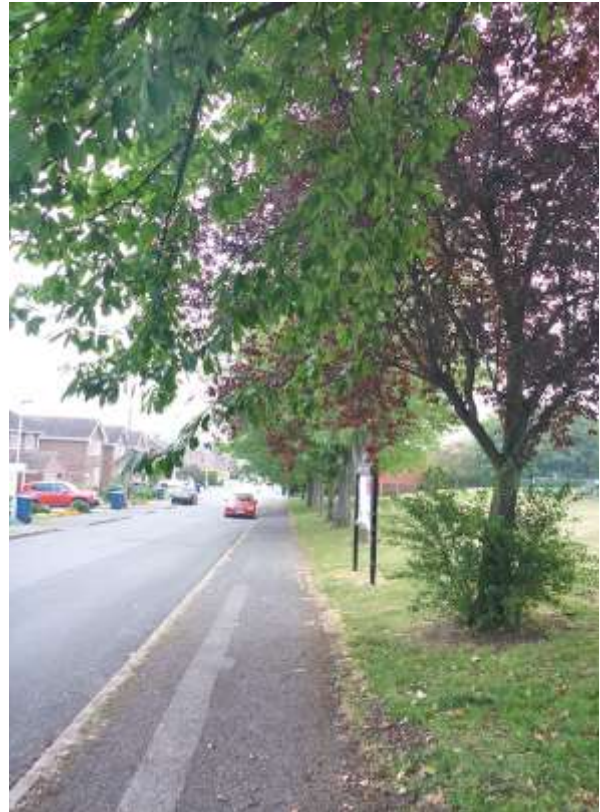
Low	capillary.froth.shiver Wynhill sports ground
2	Mixed group Mixed group	Mature	Good	Good	C2	Crown lift to 2.5m over pavements around the park. Remove epicormic growth. Clear below street lamps.

**2. Crown lift over pavements & clear lights.**

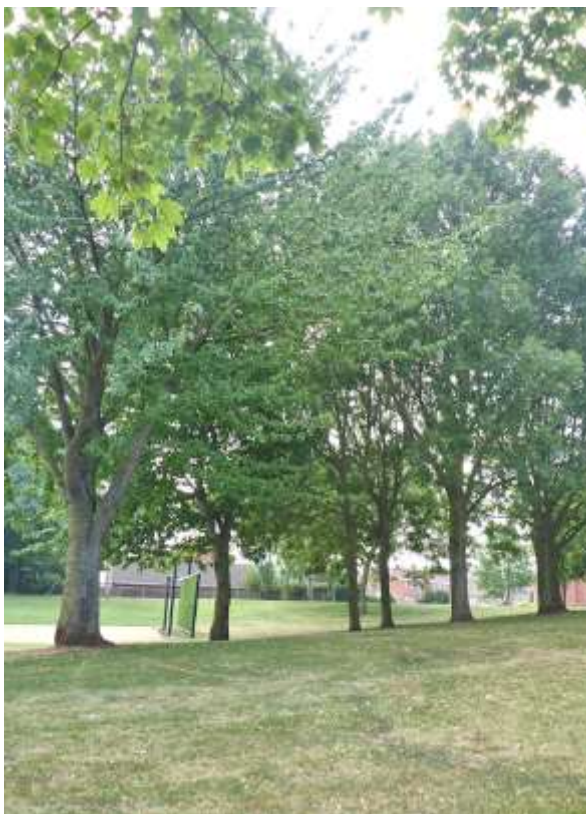
Low	defaults.message.straying Wychwood Road play area
3	Ash Fraxinus excelsior	Semi-mature	Good	Good	B2	Remove deadwood > 25mm in diameter and > 1m in length.

**3. Remove deadwood >40mm x 1m.**

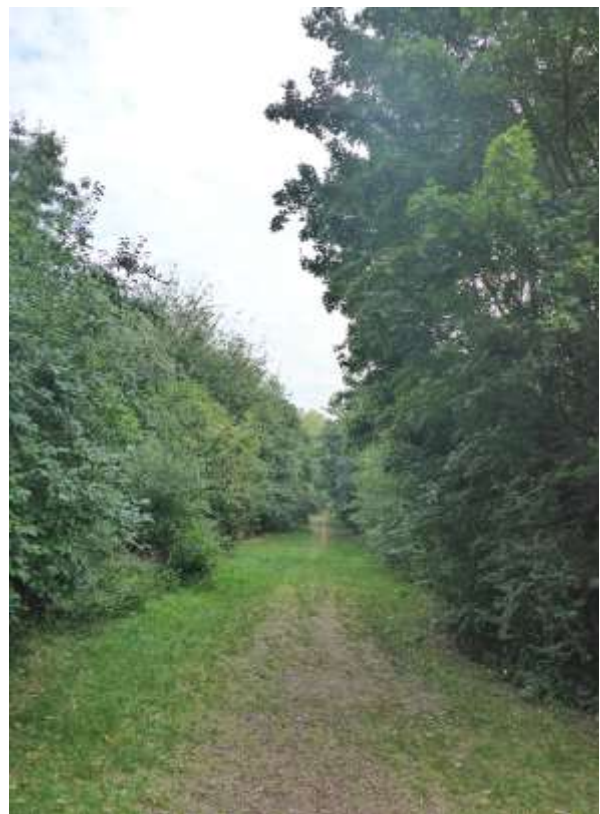
Low	treaties.beyond.afterglow Wychwood Road play area
4	Mixed group Mixed group	Mature	Fair	Fair	C2	Continue phased coppicing to maintain width of grassed walkway.

**4. Continue phased copicing.**

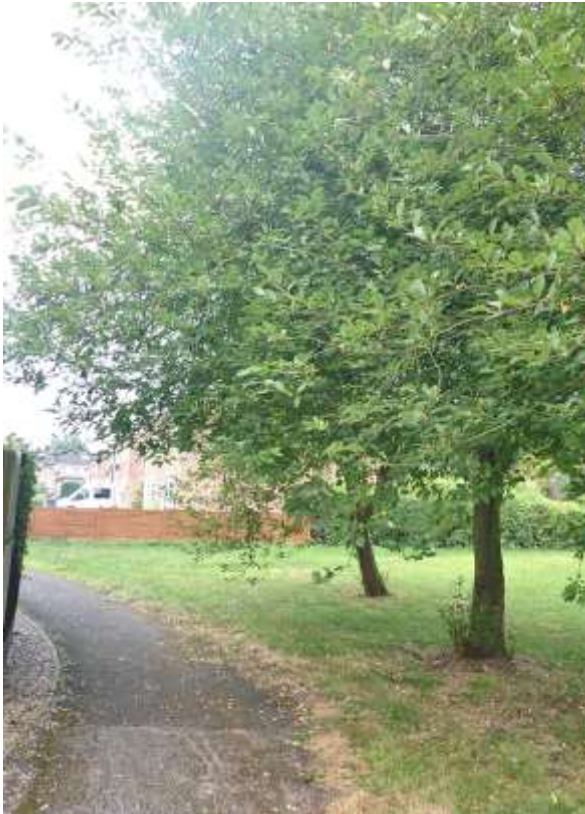
Low	cult.batches.proclaims Soundbund
5	Wild cherry Prunus avium	Mature	Good	Good	C2	Crown lift to 2.5m over pavement.

**5. Crown lift over pavement.**

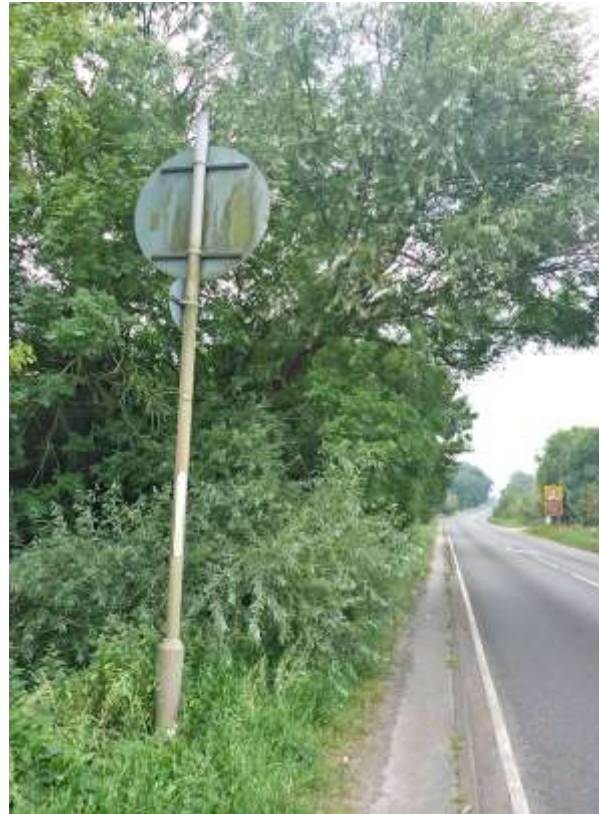
6	Crack willow Salix fragilis	Mature	Good	Fair	C2	Cut back limbs overhanging pavement and road. Cut back collapsed limb.

**6. Cut back willow over road.**

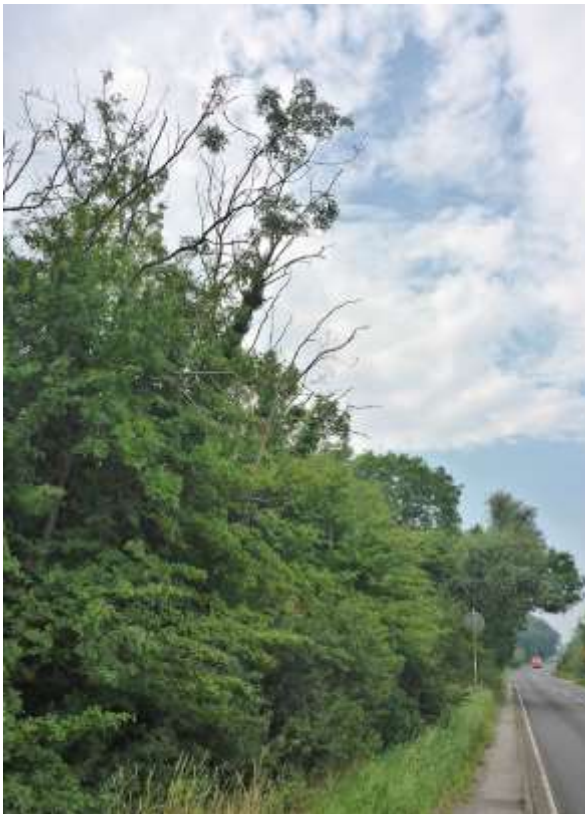
Medium	selection.tonsils.totals Old A46
7	Elm Ulmus procera		Dead	Collapsing	U	Dead elms - fell where within falling distance of road.

**7. Fell dead elms within falling distance of road.**

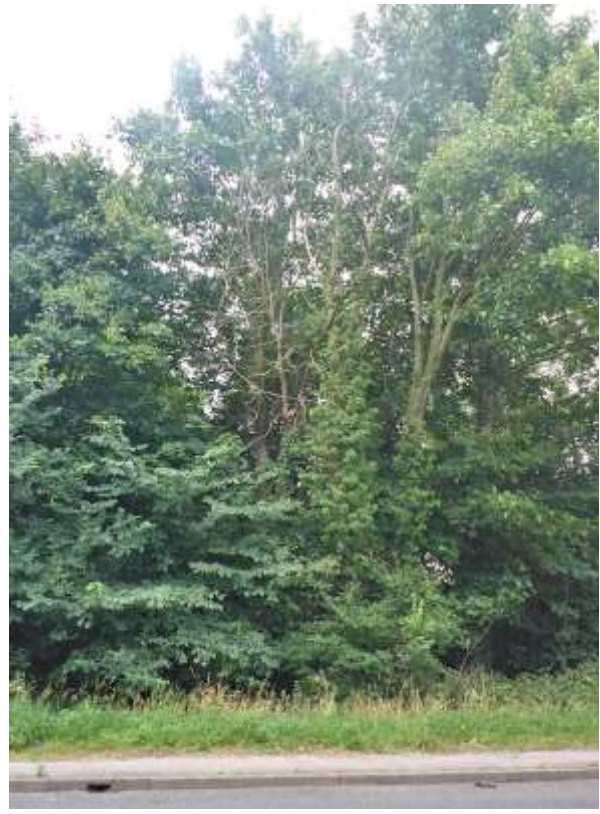
Medium	conductor.cartoons.ordering Old A46
8	Elm Ulmus procera		Dead	Collapsing	U	Dead elms - fell where within falling distance of road.

**8. Fell dead elms within falling distance of road.**

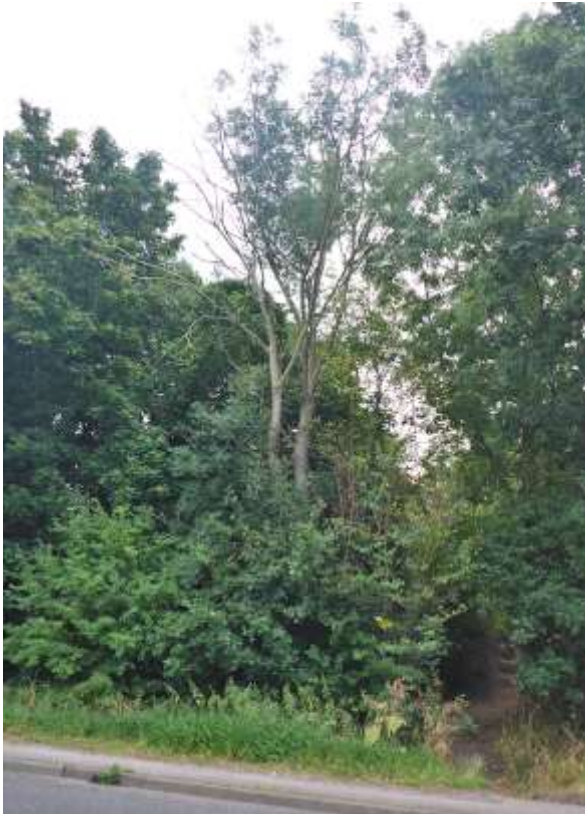
Medium	printout.recap.proved Old A46
9	Ash Fraxinus excelsior	Semi-mature	Poor	Collapsing	U	Declining canopy - fell.

**9. Fell declining ash.**

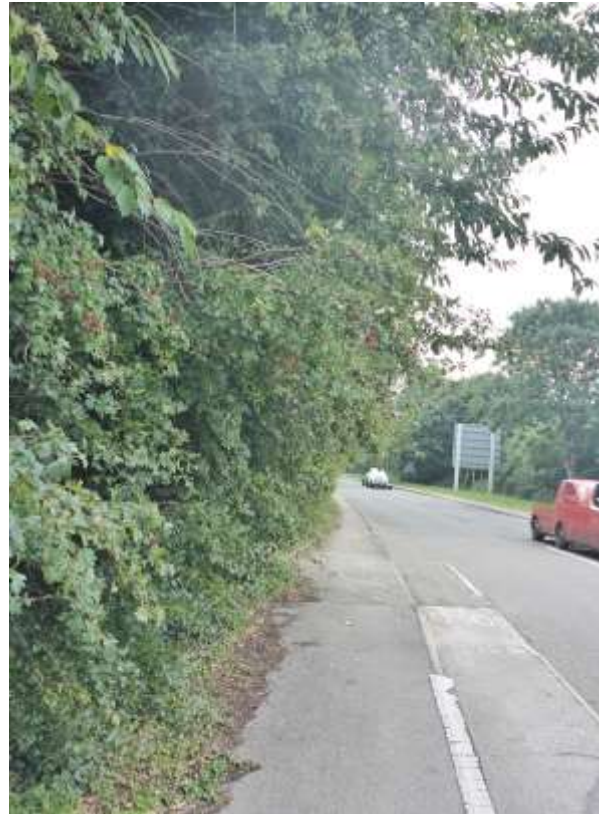
Low	autumn.hires.escalates Old A46
10	Mixed hedgerow	Mature	Good	Good	C2	Crown lift to 2.5m over pavement. (Highways?)

**10. Cut back overhanging hedge.**

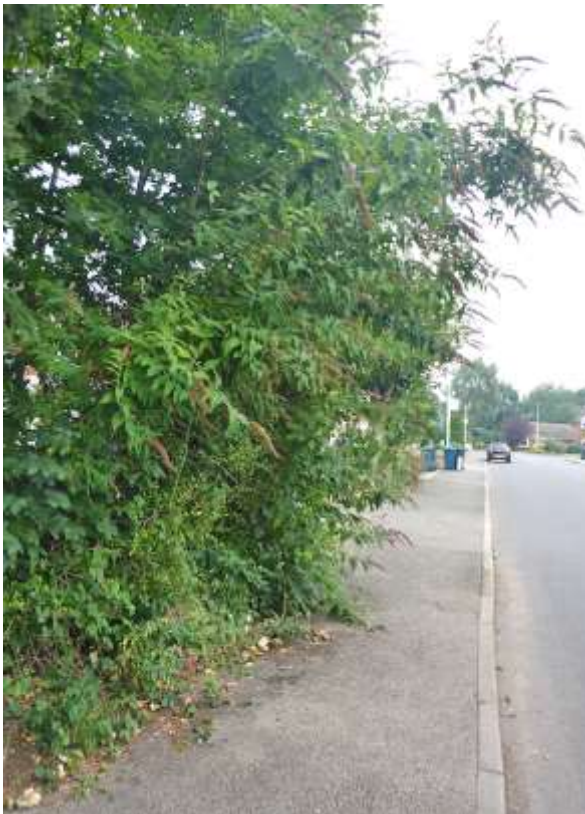
Low	hush.hedgehog.banks Nottingham Road
11	Buddleja Buddleja	Mature	Good	Good	C2	Cut back to clear pavement.

**11. Cut back buddleja overhanging pavement.**

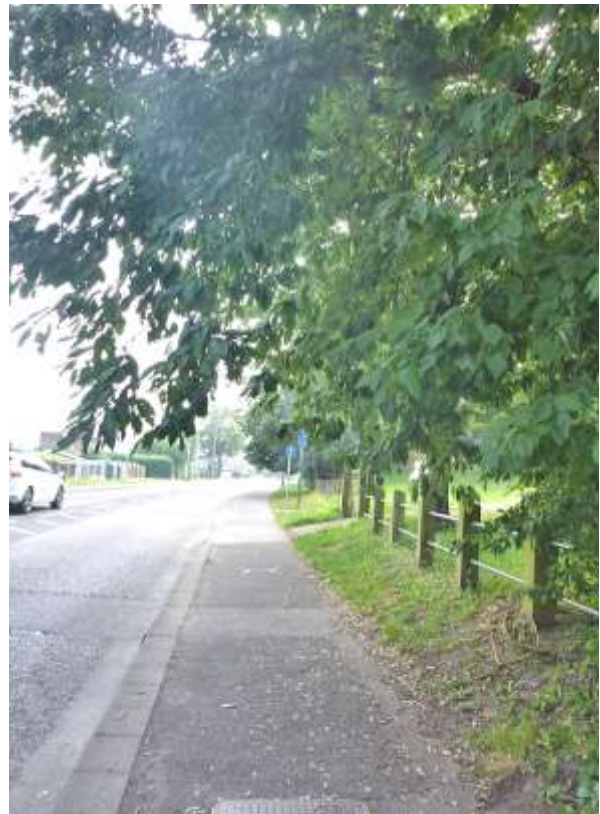
Low	plan.attention.excusing Balmoral Road
12	Cherry Prunus	Mature	Good	Good	C2	Obscuring signage. Crown lift to 2.5m over pavement.

**12. Crown lift cherry to 2.5m over pavement.**

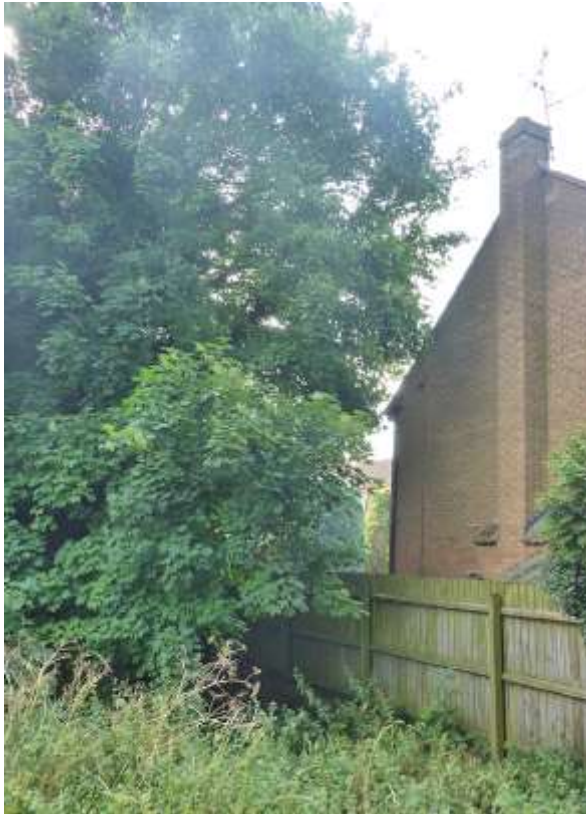
13	Sycamore Acer pseudoplatanus	Mature	Good	Good	B2	Cut back to clear property ≥ 1.5m.  	Low	downfield.revised.sands Linear Walk
14	Ash Fraxinus excelsior	Mature	Good	Good	B2	Remove split dead branch at 10m.  	Low	instilled.return.presenter Linear Walk

**13. Target prune to clear property by  $\geq 1.5\text{m}$ .**

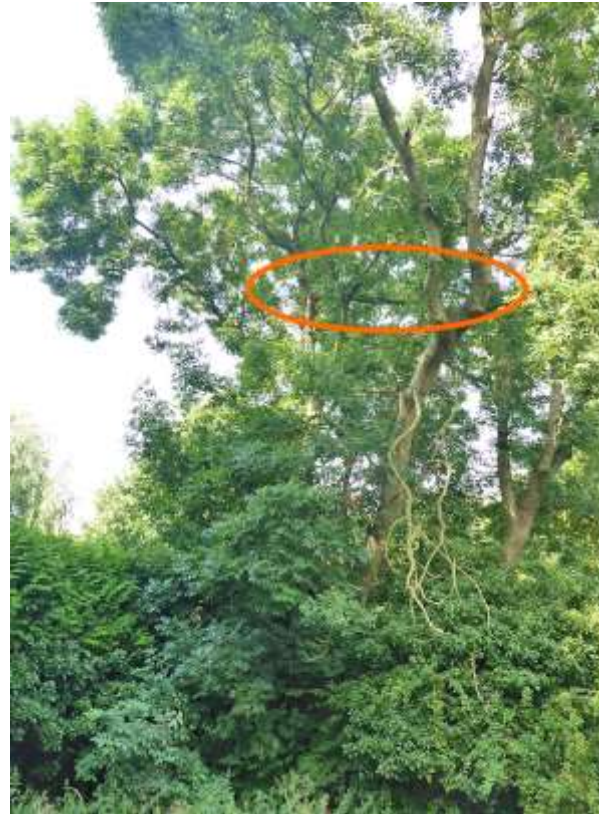
**14. Remove split dead branch from ash.**

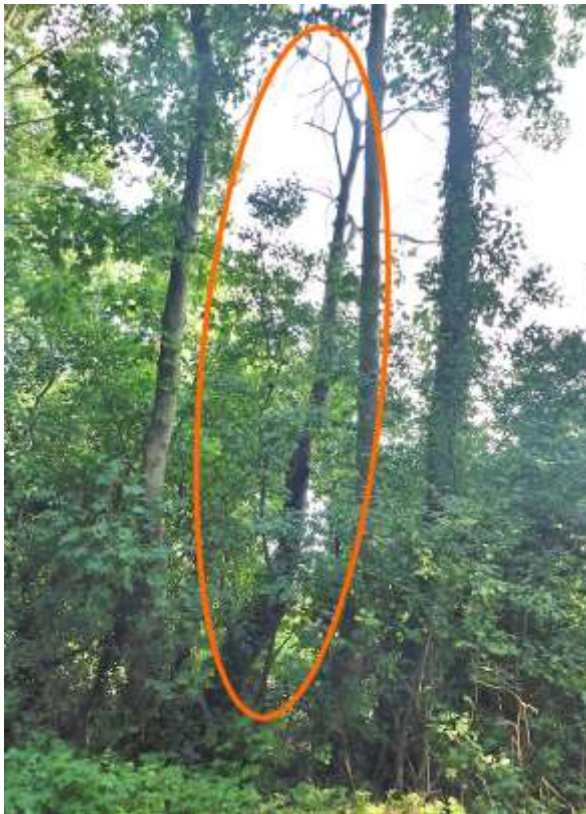
Ref.	Name/species	Age category	Physiological condition	Structural condition	BS5837 Grading	Recommendations	Priority	W3W Location
15	Sycamore Acer pseudoplatanus	Semi-mature	Dead	Collapsing	U	Dead - fell.

**15. Fell dead sycamore stem.**

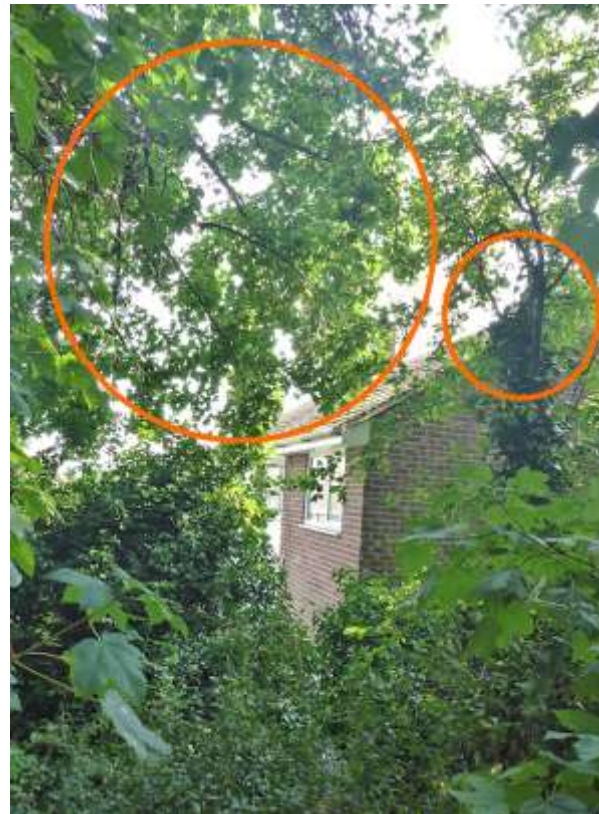
Low units.packages.cavalier Linear Walk
16	Mixed group	Mature	Good	Good	B2	Cut back/remove sycamore limb overhanging property. Cut back damsons to clear property by ≥ 1m.

**16. Cut back overhanging sycamore branch & damsons.**

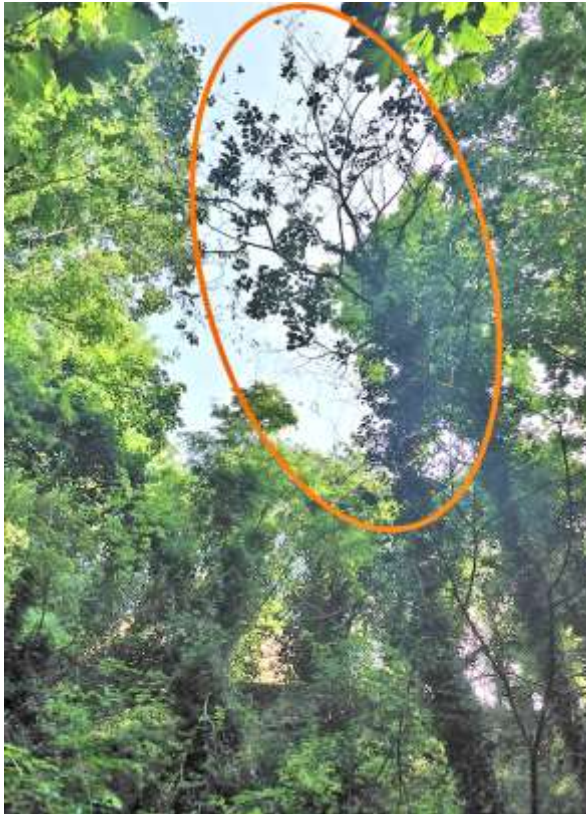
Low young.enjoys.purist Linear Walk
17	Cherry Prunus	Mature	Poor	Fair	U	Declining canopy - fell.

**17. Fell declining cherry.**

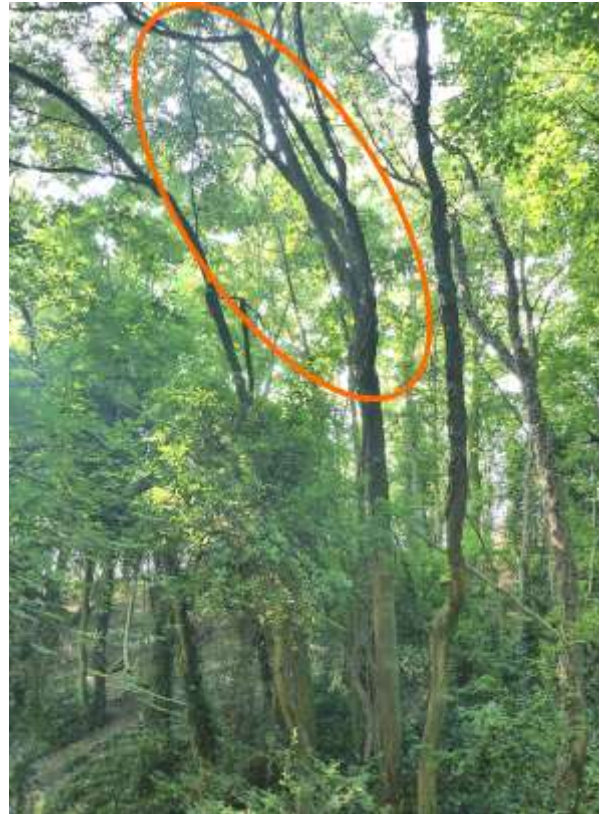
Low awakening.clerics.cares Linear Walk east side 40m beyond bridge
18	Ash Fraxinus excelsior	Semi-mature	Good	Fair	C2	Remove dead limb overhanging path.

**18. Remove dead ash branch over path.**

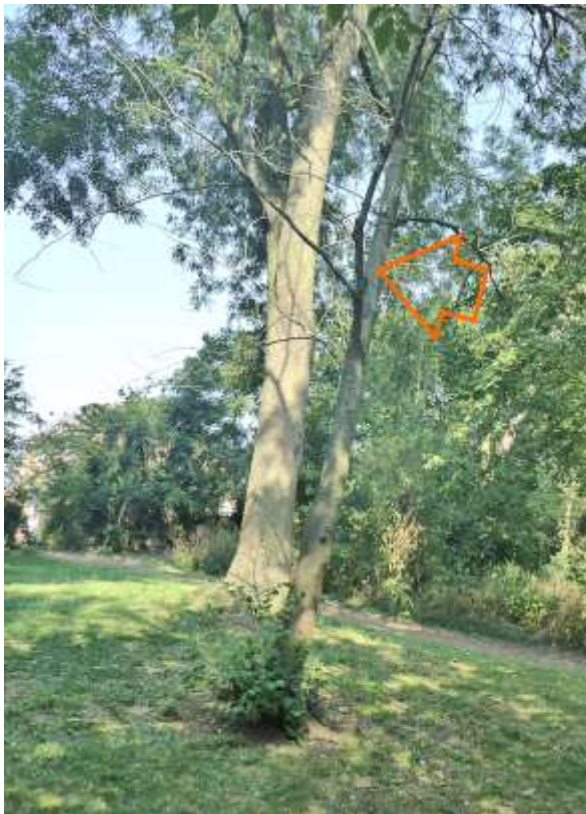
Low bicker.rejoined.frog Linear Walk west side 100m beyond bridge
19	Elm Ulmus procera		Dead	Collapsing	U	Dead - fell.

**19. Fell dead elm.**

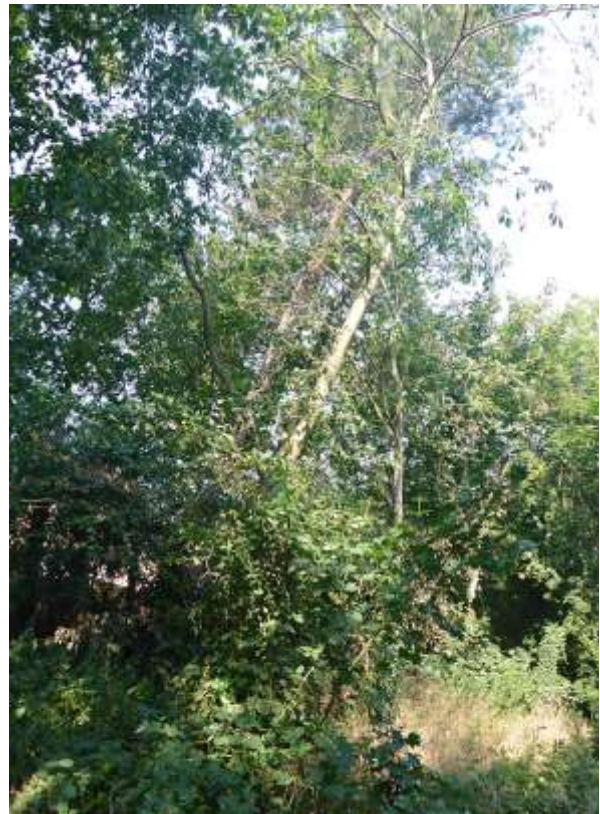
Low scribbled.fumes.atoms Tythby Road - west side
20	Elm Ulmus procera		Poor	Poor	U	Declining - OK at present but will continue to decline and will eventually need to be removed.

**20. Elm x 2 declining.**

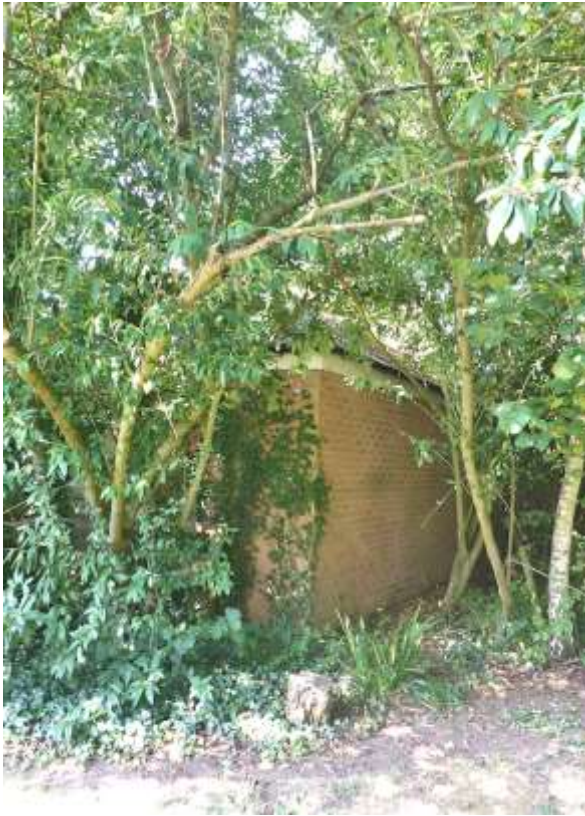
21	Cotoneaster Cotoneaster frigidus	Mature	Fair	Fair	C2	Cut back to clear garage roof by 1m.

**21. Cut back cotoeaaster to clear garage by 1m.**

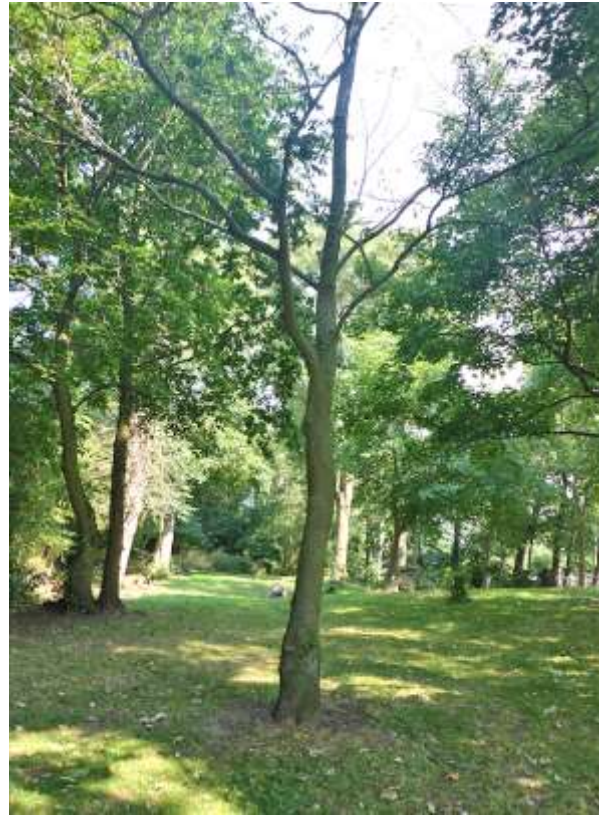
Low remedy.feuds.armrests Tythby Road - west side
22	Elm Ulmus procera		Dead	Poor	U	Dead - fell.

**22. Fell dead elm.**

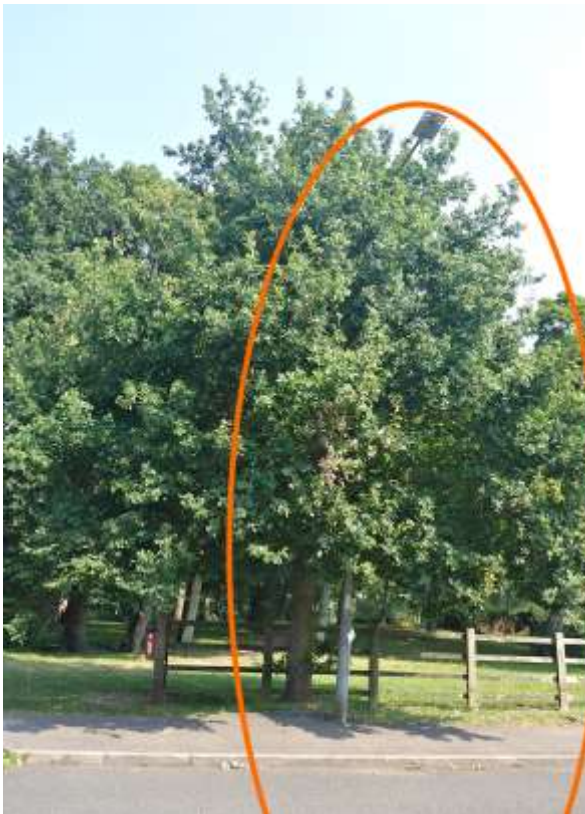
Low fenced.unlocking.calendars Tythby Road - west side
23	Oak Quercus robur	Semi-mature	Good	Good	A2	Crown lift to 2.5m over pavement. Cut back branches to edge of road to clear street lighting.

**23. Crown lift oak to 2.5 & cut back to edge of road to clear light pattern.**

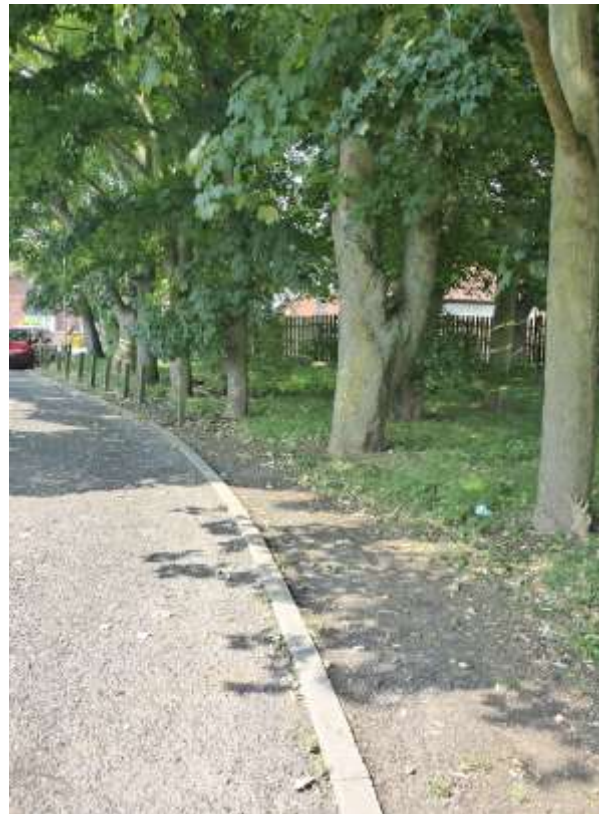
Low absorbing.gave.vaccines Mill Hill Road
24	Sycamore Acer pseudoplatanus	Mature	Good	Good	B2	Crown lift to 4m over road. If possible, reinstate posts to prevent parking on top of roots. (Check for electricity cables.) If using concrete/postcrete use impermeable liner to prevent soil contamination.

**24. Crown lift to 4m and, if possible, reinstate posts to prevent parking over roots.**

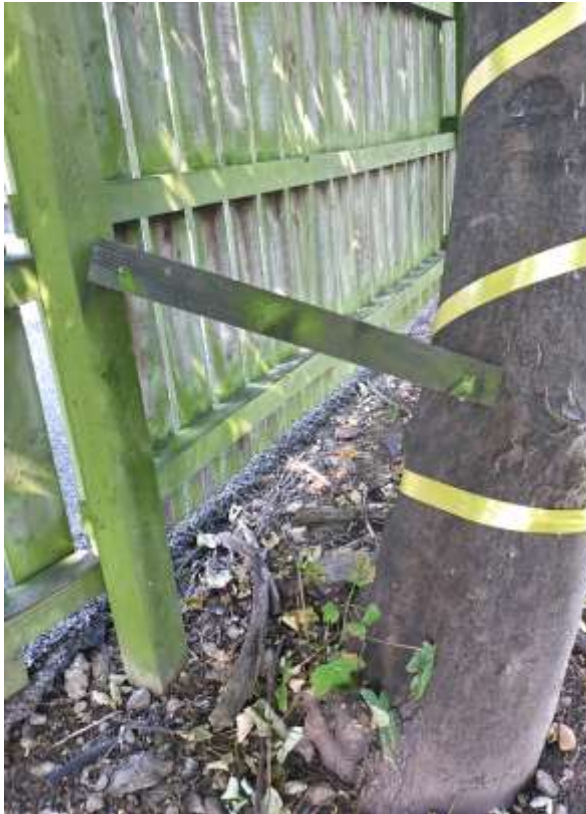
Low obstinate.likely.discount Langtree Gardens
25	Sycamore Acer pseudoplatanus	Semi-mature	Good	Good	B2	Remove fence support. Now becoming embedded and harming tree.

**25. Remove fence support strut which is damaging tree.**

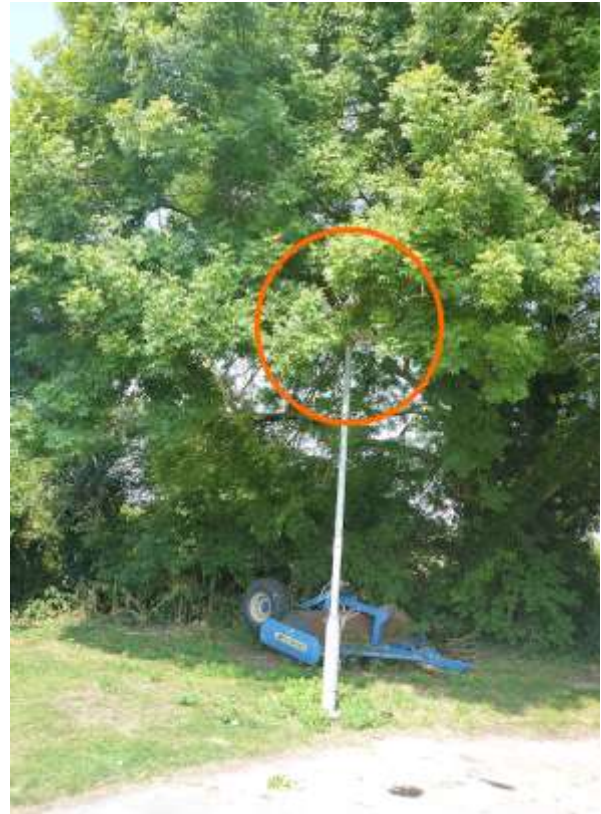
26	Ash Fraxinus excelsior	Mature	Good	Good	B2	Target prune to clear lamp pattern and security cameras.

**26. Target prune ash to clear lamp & security cameras.**

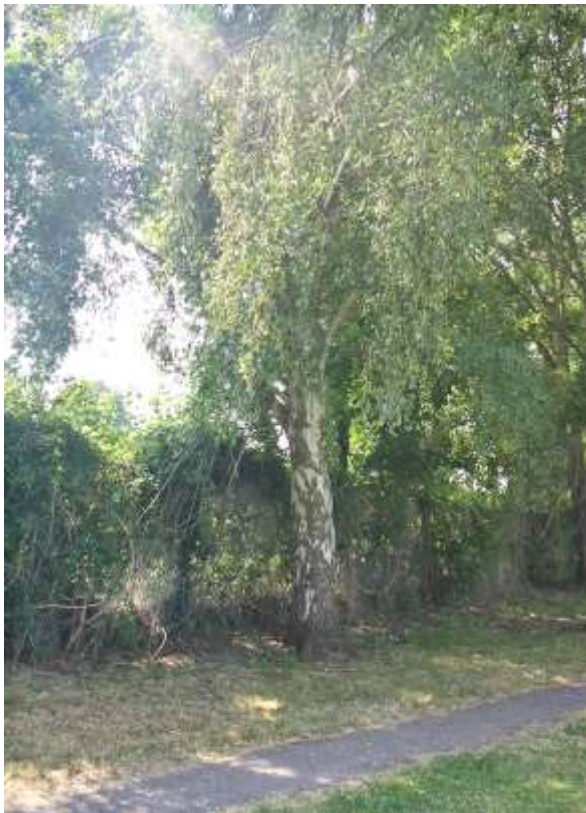
Low evenings.lanes.conqueror Butt Field
27	Mixed group	Mature	Good	Good	B2	Cut Russian vine to prevent it overwhelming birch & ash canopies.

**27. Cut vine to prevent smothering of canopies.**

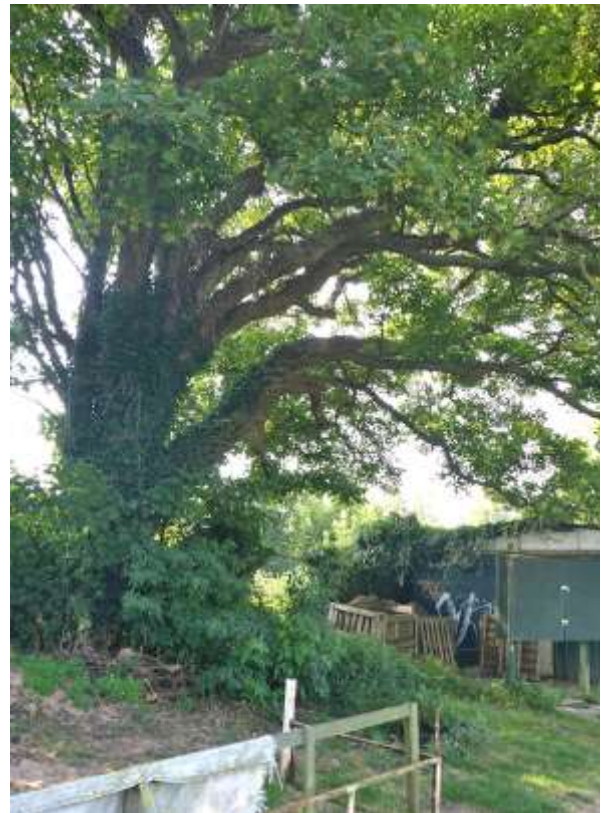
Ref.	Name/species	Age category	Physiological condition	Structural condition	BS5837 Grading	Recommendations	Priority	W3W Location
28	Sycamore Acer pseudoplatanus	Mature	Good	Fair	B2	Remove hanging branch at 6m in centre of canopy. Target prune to clear building by 1m.

**28. Remove dead branch & crown lift over building.**

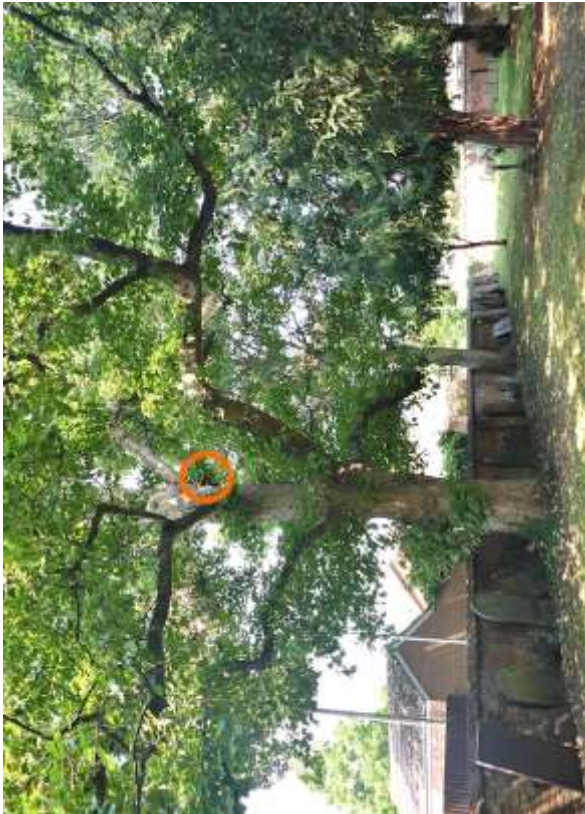
Low	directors.reserving.flocking Butt Field
29	Sycamore Acer pseudoplatanus	Mature	Good	Good	A2	Remove deadwood > 25mm in diameter and > 1m in length. Fungal bracket ( <i>Polyporus Squamosus</i> ) not usually serious - watching brief.

29. Remove dead wood >40mm x 1m.

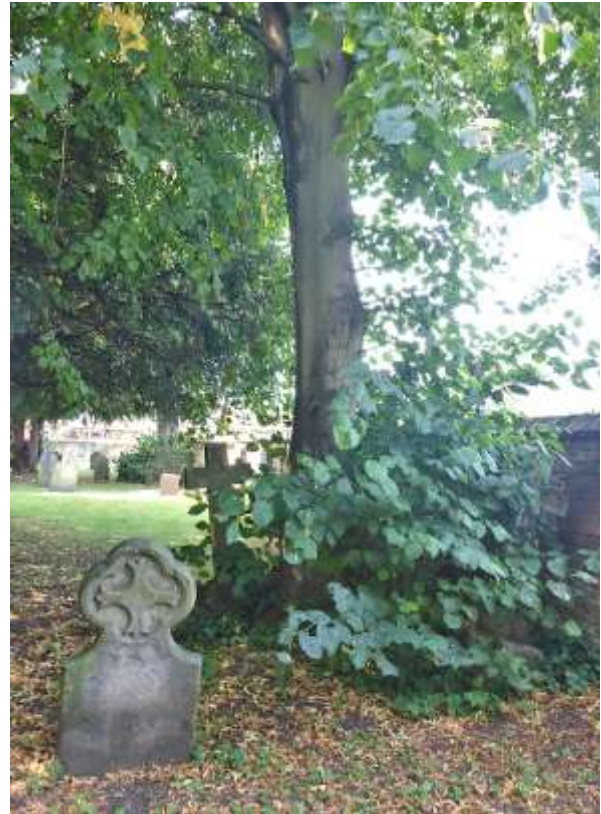
Low	visions.amphibian.reactiving Churchyard
30	Lime Tilia x europaea	Mature	Good	Good	A2	5 trees - remove epicormic growth and crown lift to 4m.

30. Crown lift limes x 5 to 4m & remove epicormic growth.

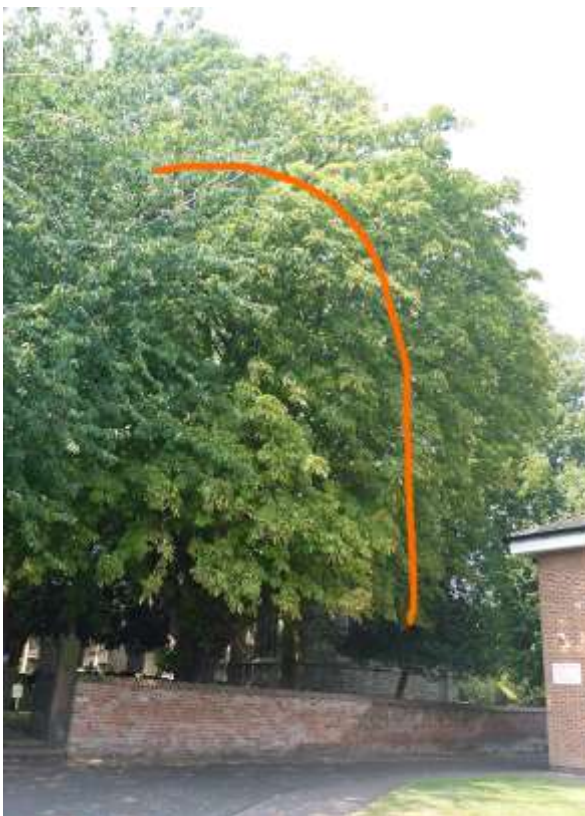
Low	proved.airports.vets Around perimeter of churchyard
31	Horse chestnut Aesculus hipposcastanum	Mature	Good	Fair	A2	Crown reduce to take weight out of canopy. Reduce height by 5m and spread by 4m on NE side and 2m elsewhere. N.B. Conservation area.

31. Crown reduce horse chestnut.

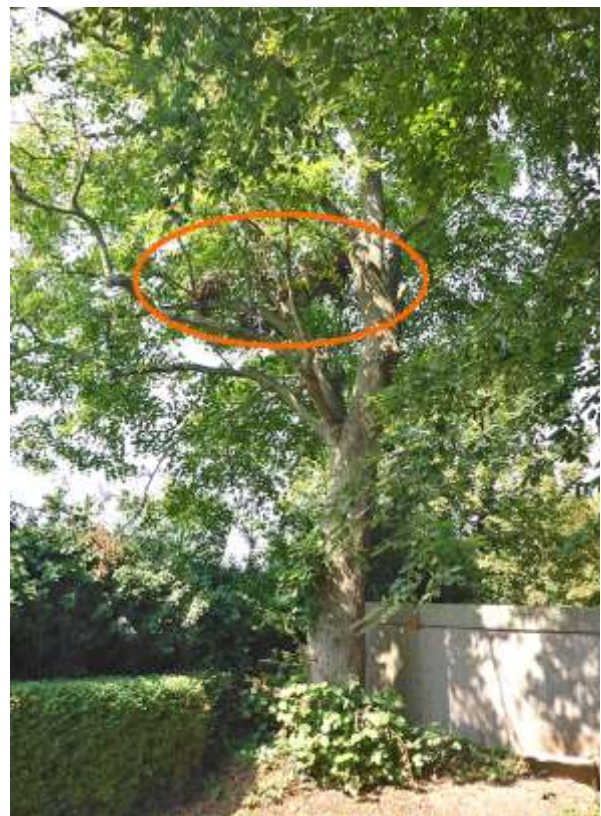
32	Lime Tilia x europaea	Mature	Good	Good	A2	Remove split branch over garage.

32. Remove split lime branch over garage.

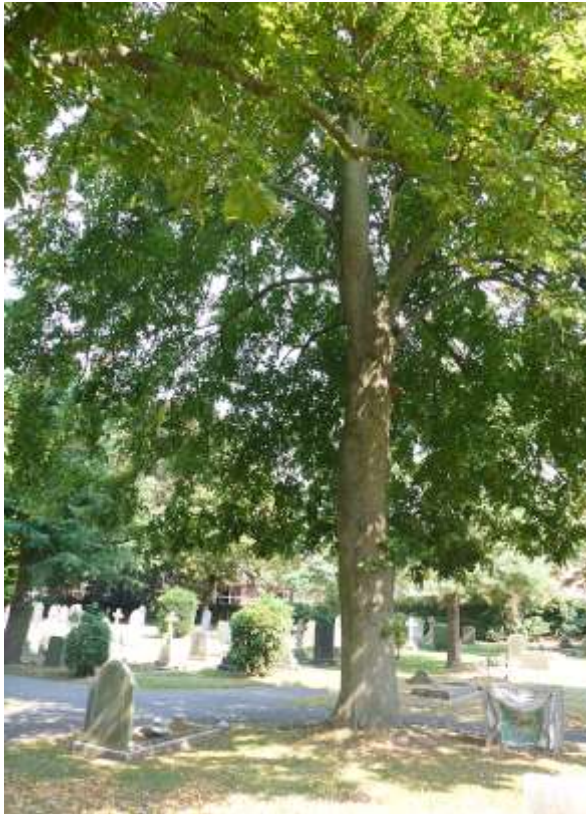
Low	slang.glorified.burying Cemetery
33	Lime Tilia x europaea	Mature	Good	Good	A2	Remove dead wood > 40mm in diameter and > 1m in length.

**33. Remove dead wood >40mm x 1m.**

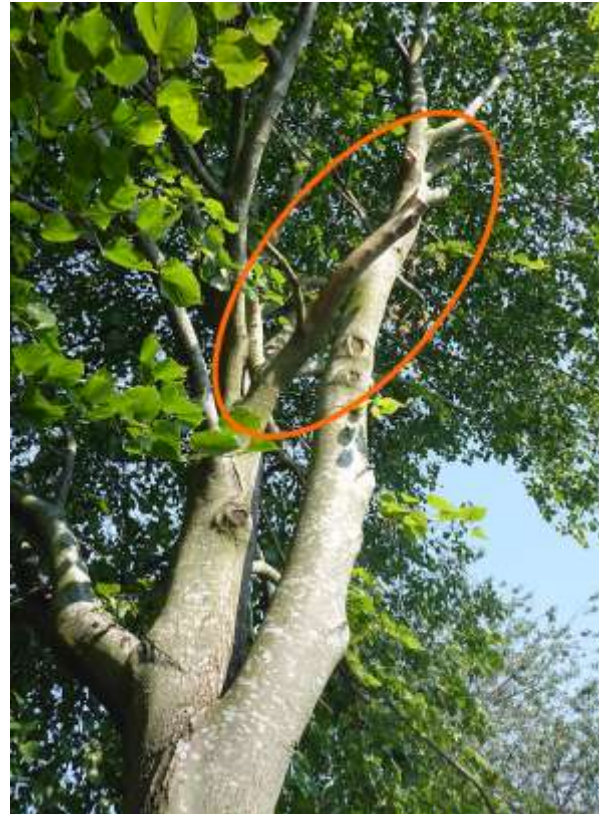
Low	mixer.forever.activates Cemetery
34	Lime Tilia x europaea	Semi-mature	Good	Good	A2	Correct poor pruning cuts and clear fly tipped waste.

**34. Correct pruning cuts & clear fly tipping.**

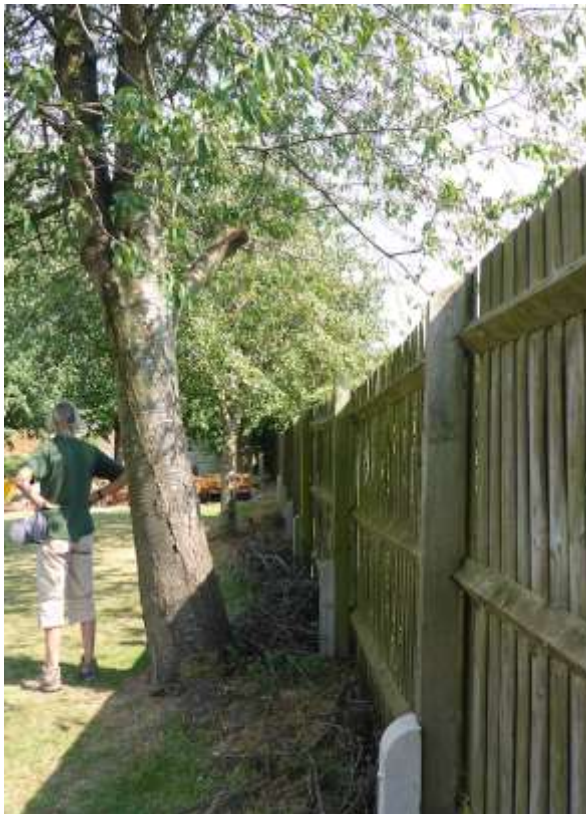
Low	fragment.unfounded.professes Cemetery
35	Cherry Prunus	Mature	Good	Good	C2	Correct poor pruning cuts and clear fly tipped waste.

**35. Correct pruning cuts & clear fly tipping.**

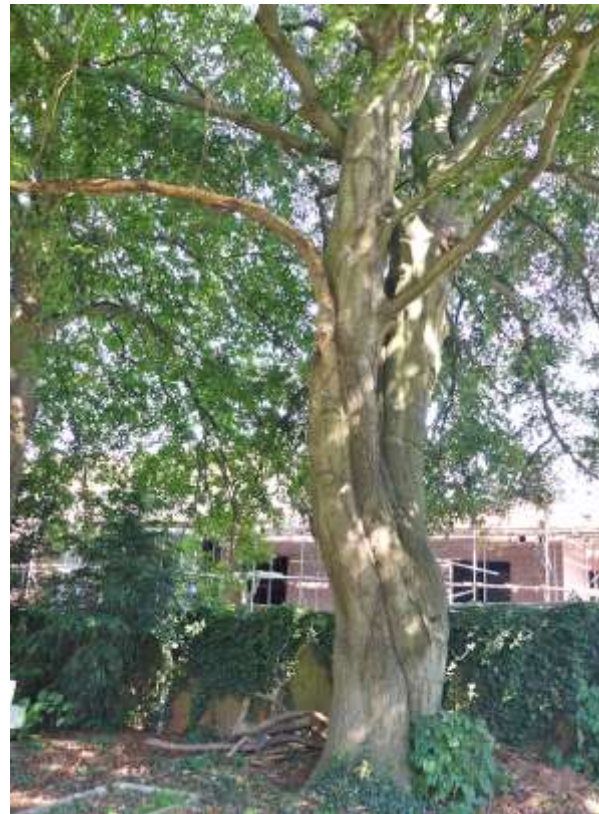
Low	basics.assist.inner Cemetery
36	Beech Fagus sylvatica	Mature	Good	Good	A2	Remove dead wood > 40mm in diameter and > 1m in length.

**36. Remove dead wood >40mm x 1m.**

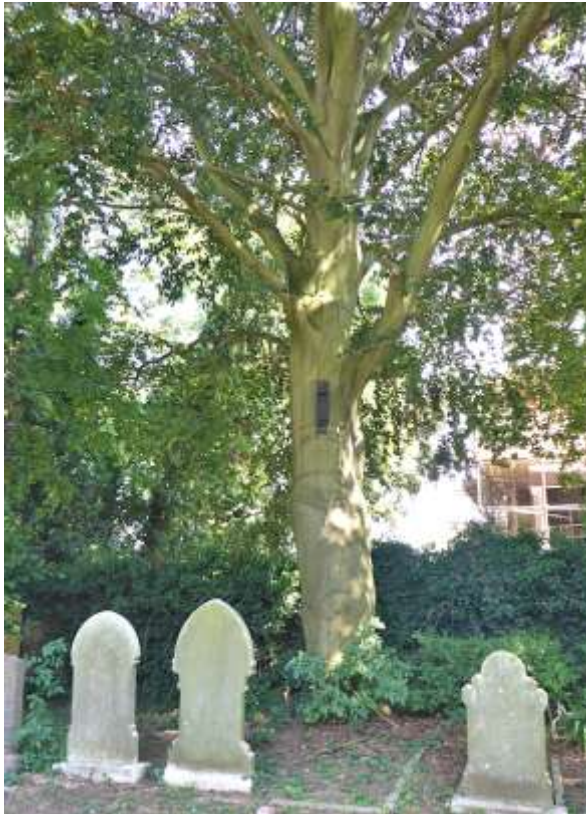
Low	wires.munch.rucksack Cemetery
37	Beech Fagus sylvatica	Mature	Good	Good	A2	Remove dead wood > 40mm in diameter and > 1m in length.

**37. Remove dead wood >40mm x 1m.**

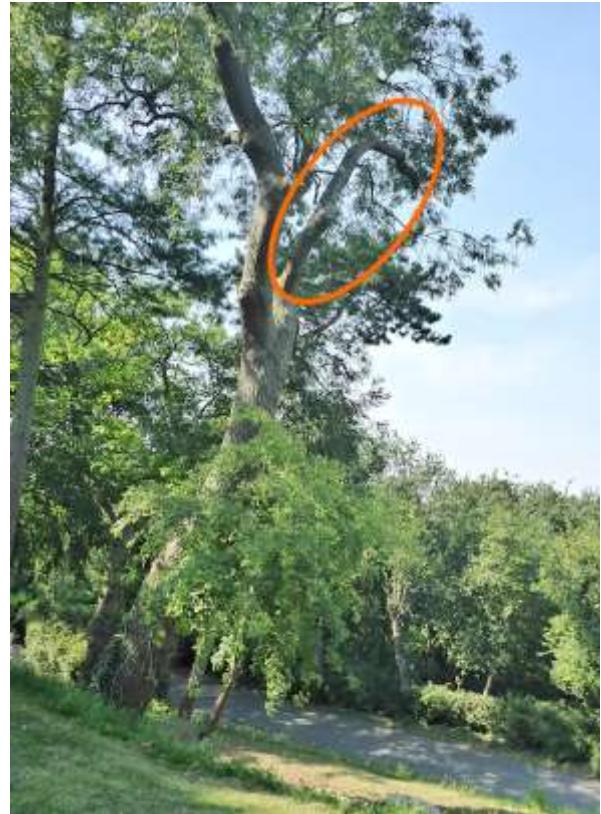
Low	huddle.bibs.dodging Cemetery
38	Ash Fraxinus excelsior	Mature	Good	Fair	B2	Cut back broken limb overhanging The Banks. Retain stump of 0.5m.

**38. Cut back broken ash branch over The Banks.**

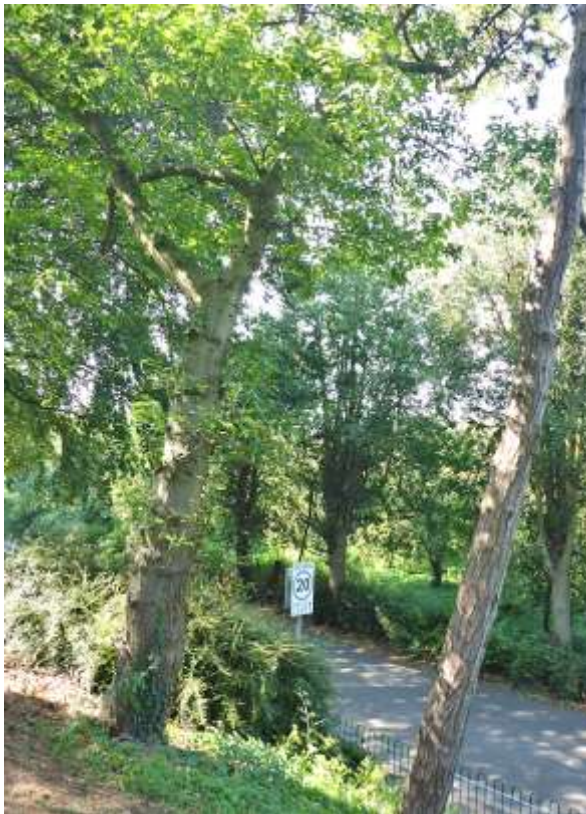
39	Red oak Quercus rubra	Early-mature	Good	Fair	B2	Remove dead wood > 40mm in diameter and > 1m in length over The Banks.

**39. Remove dead wood >40mm x 1m over Banks.**

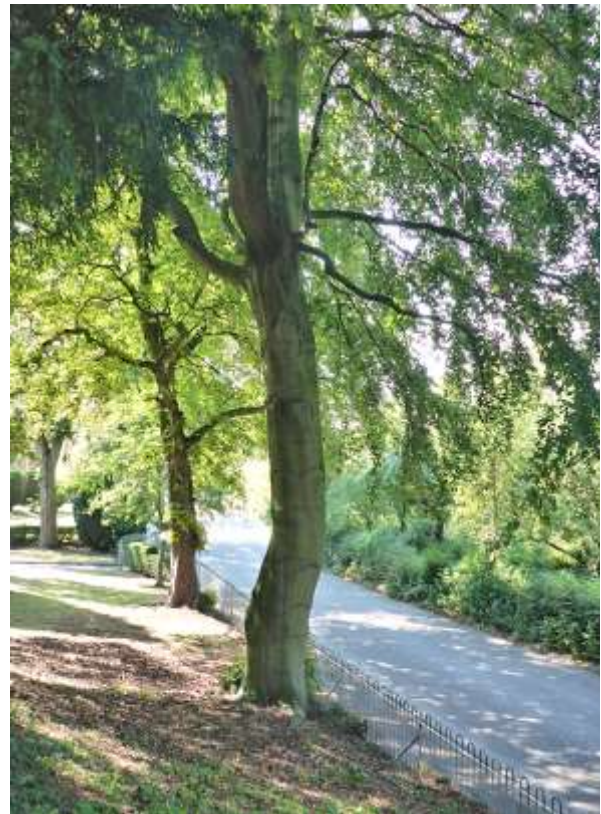
Low	respect.roadblock.amplified Cemetery
40	Beech Fagus sylvatica	Mature	Good	Good	A2	Remove dead wood > 40mm in diameter and > 1m in length over The Banks.

**40. Remove dead wood >40mm x 1m over Banks.**

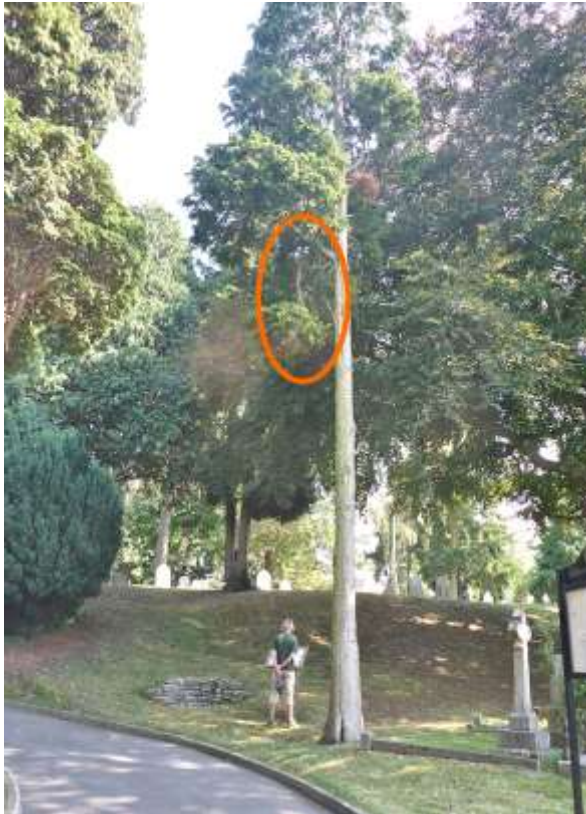
Low	opened.nickname.gourmet Cemetery
41	Lawson cypress Chamaecyparis lawsoniana	Mature	Good	Good	C2	Remove split branch in crown break at 9m.

**41. Remove split branch at 9m.**

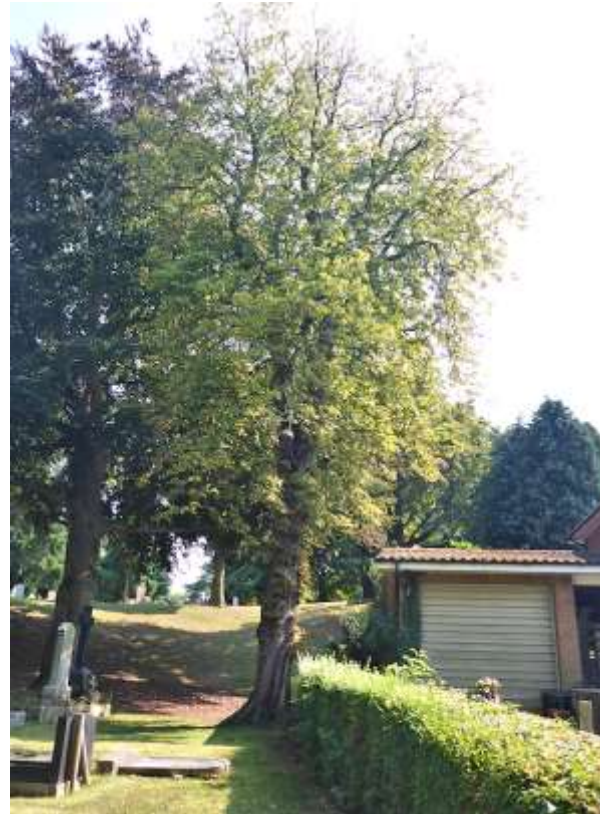
Ref.	Name/species	Age category	Physiological condition	Structural condition	BS5837 Grading	Recommendations	Priority	W3W Location
42	Horse chestnut Aesculus hippocastanum	Mature	Fair	Fair	B2	Some dieback in canopy. Review May 2021.

**42. Some dieback in canopy – review May 2021.**
