## **Tree Condition Report for Bingham Town Council**

**12th August 2020**

# AT2 Tree Surveys

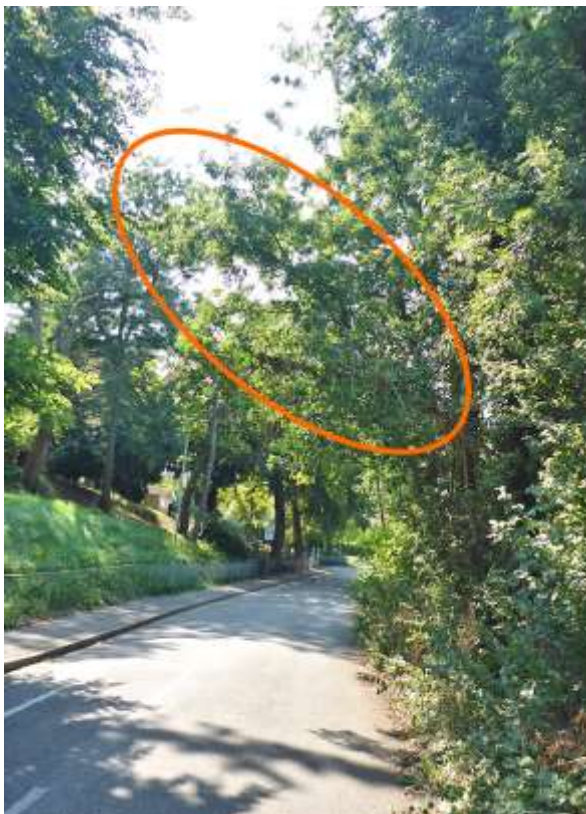
Low	quickly.breaches.opposing Cemetary
43	Ash Fraxinus excelsior	Young	Poor	Collapsing	U	Remove stem collapsing over The Banks.

- Although ownership is unclear, item 43 requires urgent attention – the branch could be hit by oncoming traffic.
- The responsibility/ownership of the willows on the south side of Crow Close is unknown.

**43. Remove stem collapsed into road.**

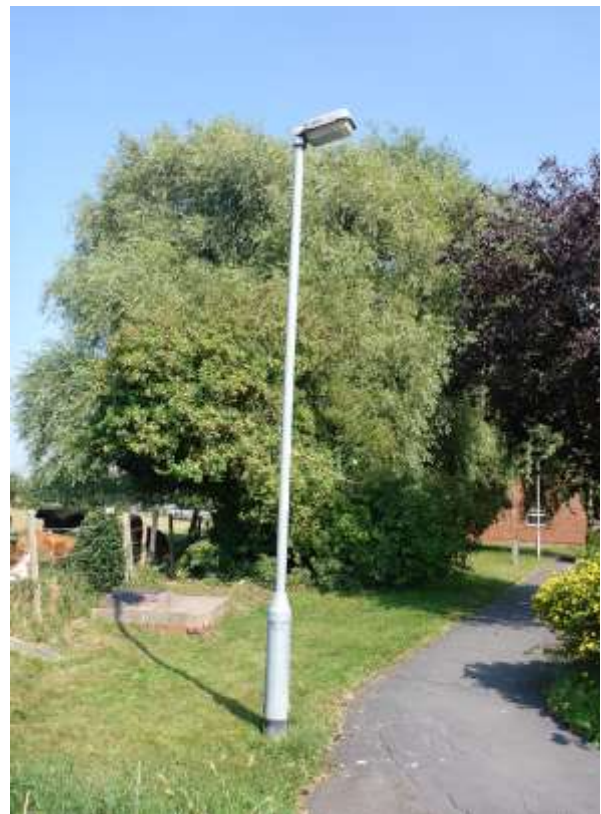
High	good.otter.fits The Banks
44	Crack willow Salix fragilis	Mature	Fair	Fair	C2	Remove deadwood. Ownership/liability?

**44. Deadwood willows – ownership unknown.**

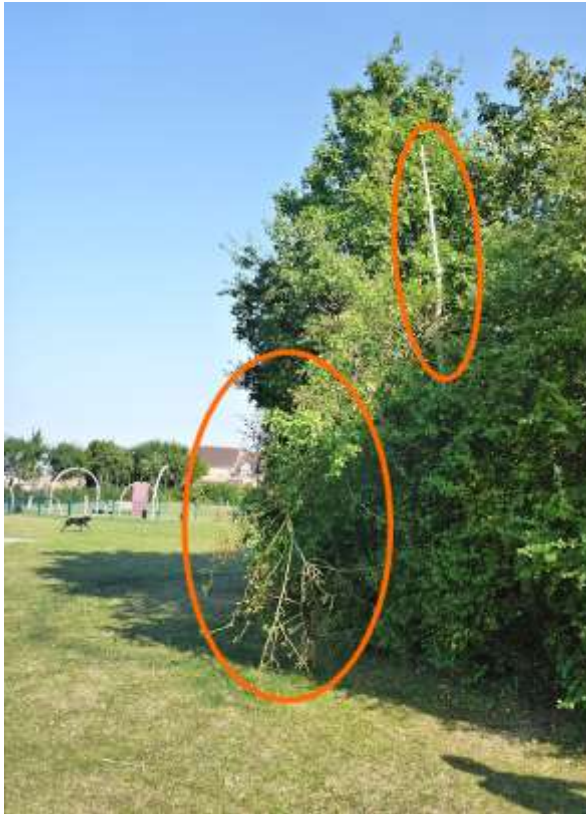
Low	spouse.remaking.quite Crow Close
45	Mixed group	Semi-mature			C2	Remove dead birch and cut back collapsed rose stems. Continue phased coppicing around perimeter.

**45. Remove collapsed rose & dead birch.**
