## **Tree Condition Report for Bingham Town Council**

**12th August 2020**

# AT2 Tree Surveys

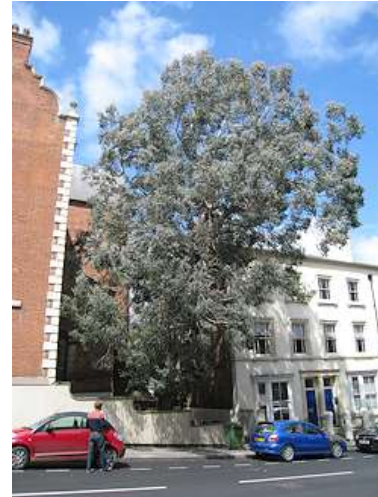
Trees overhanging roads may be a nuisance to traffic. Crown lifting to around 5.5 metres is sufficient for trucks and buses though in practice, on busy roads the passage of traffic tends to knock off any new growth that might cause an obstruction.

Branches over pavements should be lifted to a clearance of 2.5 metres. Low branches are particularly hazardous for partially sighted pedestrians.

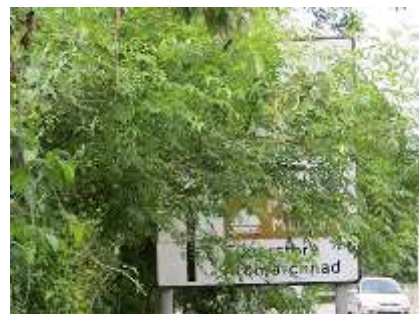
It is common for trees to have some dead wood in the crown where branches have died back. Dead wood has good habitat value but it can present a hazard to people and property below. In high risk areas such as paths, play areas and property it is recommended that dead wood greater than 25mm in diameter and more than a metre long is removed. In low risk areas it is recommended that dead wood greater than 40mm is removed.

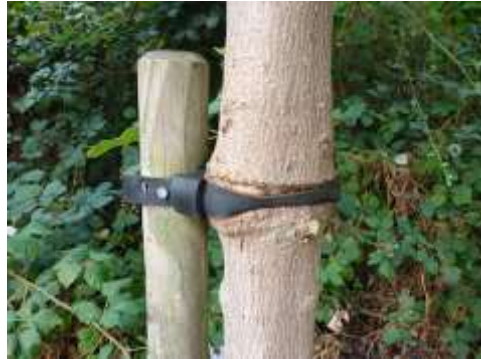
Many of the stakes and ties used to support young trees are still attached many years later. This causes two problems. As the girth of the tree grows the tie becomes embedded and can effectively strangle the tree. Also, when over-staked the tree is not encouraged to become self-supporting and so, when the stake eventually rots away, the tree loses its support and collapses. Trees should typically only be staked for the first two growing seasons. The ties should be flexible and there should be a rubber spacer block between the tree and the stake to prevent chaffing.

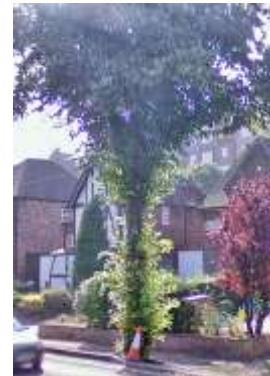
Trees such as lime and sycamore can produce bushy epicormic growth around the trunk. This does no harm but it gives a cluttered appearance and may be considered unsightly. The young growth can be safely removed to leave a clear stem. This is often carried out in conjunction with crown lifting where lower branches are pruned to raise the canopy. "Crown cleaning" is a term used for a combination of dead wooding and removal of cluttered growth.

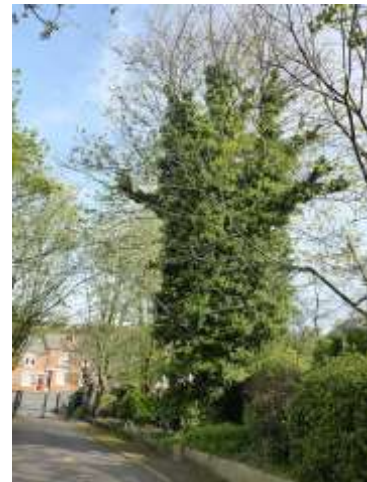
Ivy has many habitat benefits for wildlife but its presence in trees can have disadvantages. It can outcompete and overshadow weaker trees – this is common in older hawthorns. Whilst it doesn't take anything directly from the tree it does use the tree for support. Large growths can be very heavy and will increase the sail area which can lead to failure in strong winds. Ivy may also obscure other problems such as fungal brackets or areas of decay. In low risk areas it may be beneficial to retain ivy for its habitat value but in higher risk areas it should be carefully cut to leave a clear section of trunk and allowed to die back ("ringed"). Care should be taken not to cut the bark of the tree resulting in damage to the cambium layer below.

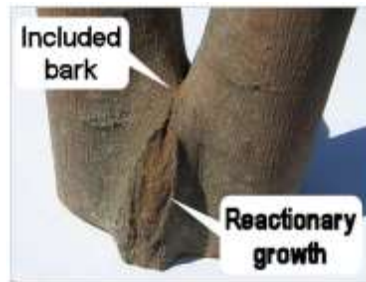
### 'V' shaped union with included bark

Where the stems have grown in a tight 'V' shape bark may have been trapped in the junction in between. The trapped or 'included' bark prevents the tree forming a strong joint between the stems.

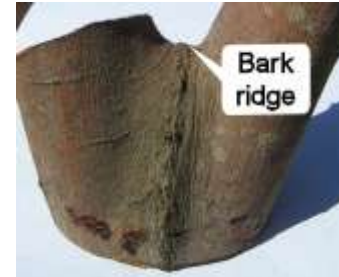
### 'U' shaped union with bark ridge

A more open 'U' shape forms a stronger union with no included bark.

Instead the bark maintains a barrier or crack that weakens the union.

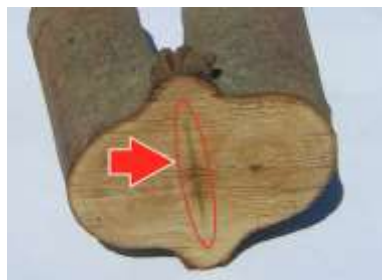
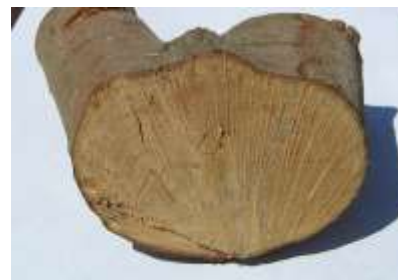
Another example showing a crack formed by included bark

The tree will produce reactionary growth forming ribs at the ends of the crack to bind the stems. The size of these ribs is a strong indicator as to the extent of the bark inclusion.

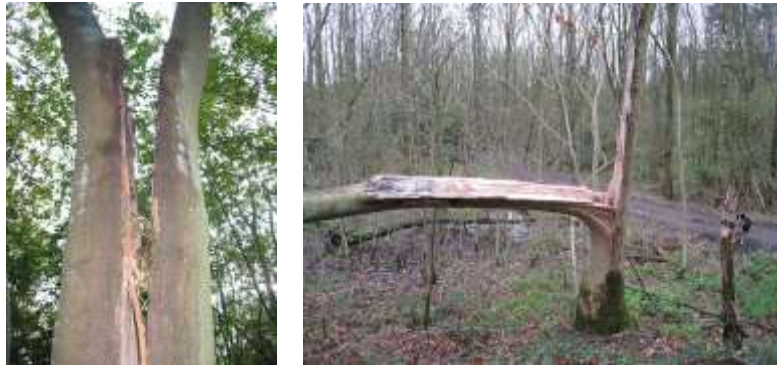
The presence of codominant stems with included bark reduces the strength of the union and therefore increases the risk of failure under loading during strong winds.

**Failed ash tree with two codominant stems.**
